**Water Facility Map
of
1946 and Earlier Water
Distribution Piping**

June 16, 2016

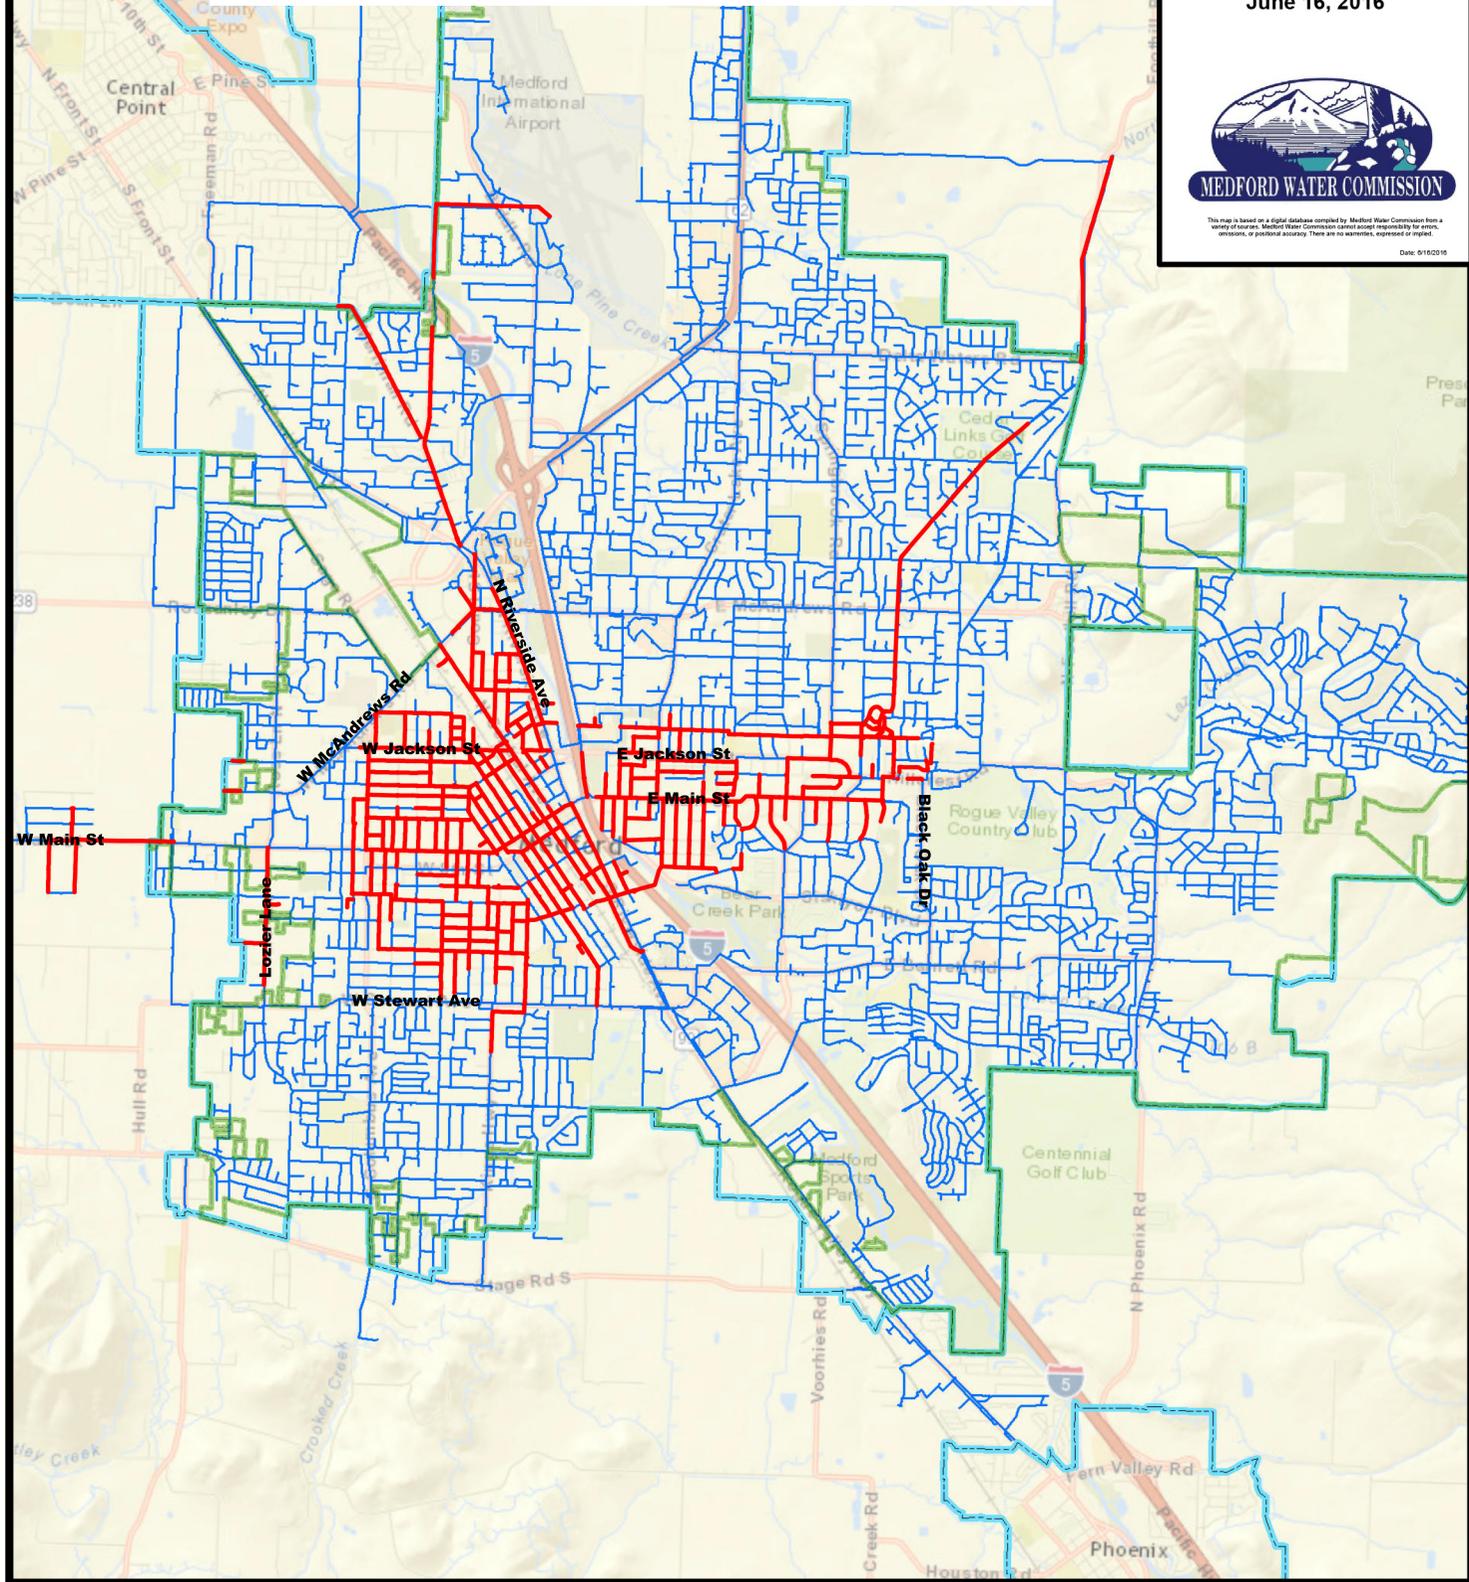
The **red lines** indicate water mains that are older than 1946. The Medford Water Commission is checking all meter boxes served by these older water mains to see whether the service line is galvanized or copper pipe. If the line is galvanized, which indicates a likelihood the service could have a lead pigtail, we will notify the customer and investigate further to determine whether there is a lead pipe that needs to be removed.
